Patellar Osteochondral Fragment Fixation Using ActivaPin™ - 11 Year-old Child

Juha-Jaakko Sinikumpu

Pediatric Orthopedic Surgeon

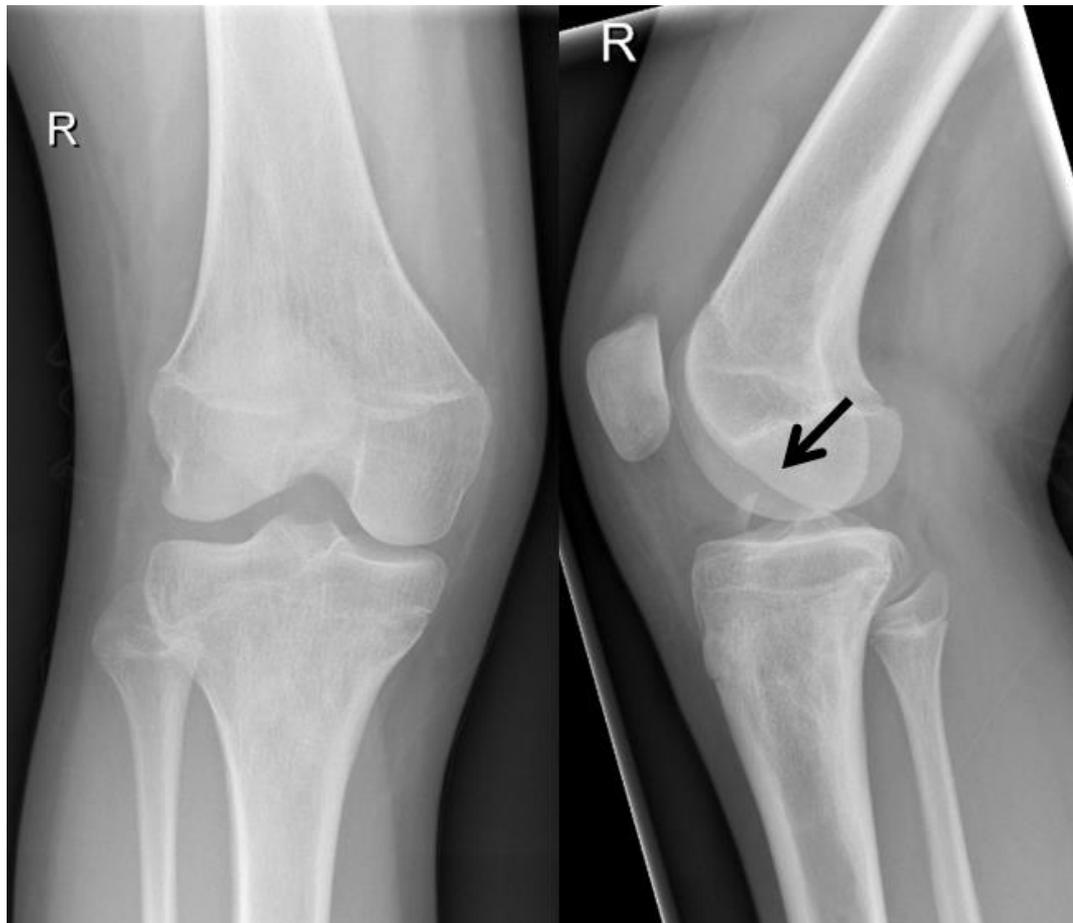
Figure 1 Primary radiographs showed a loose bone fragment in the knee joint

In the primary radiographs a loose bone fragment was seen in the knee joint (Figure 1). It was located in the eminentia area but the origin of the fragment was not clear. A computer tomography (CT) imaging was performed. The CT showed that the fragment was originating from a stress-bearing area, the distal apex of the patellae. It was about 10x10 mm in size and it comprised both joint cartilage surface and a thin layer of underlying bone tissue (Figure 2). No other acute musculoskeletal findings were seen in the CT.

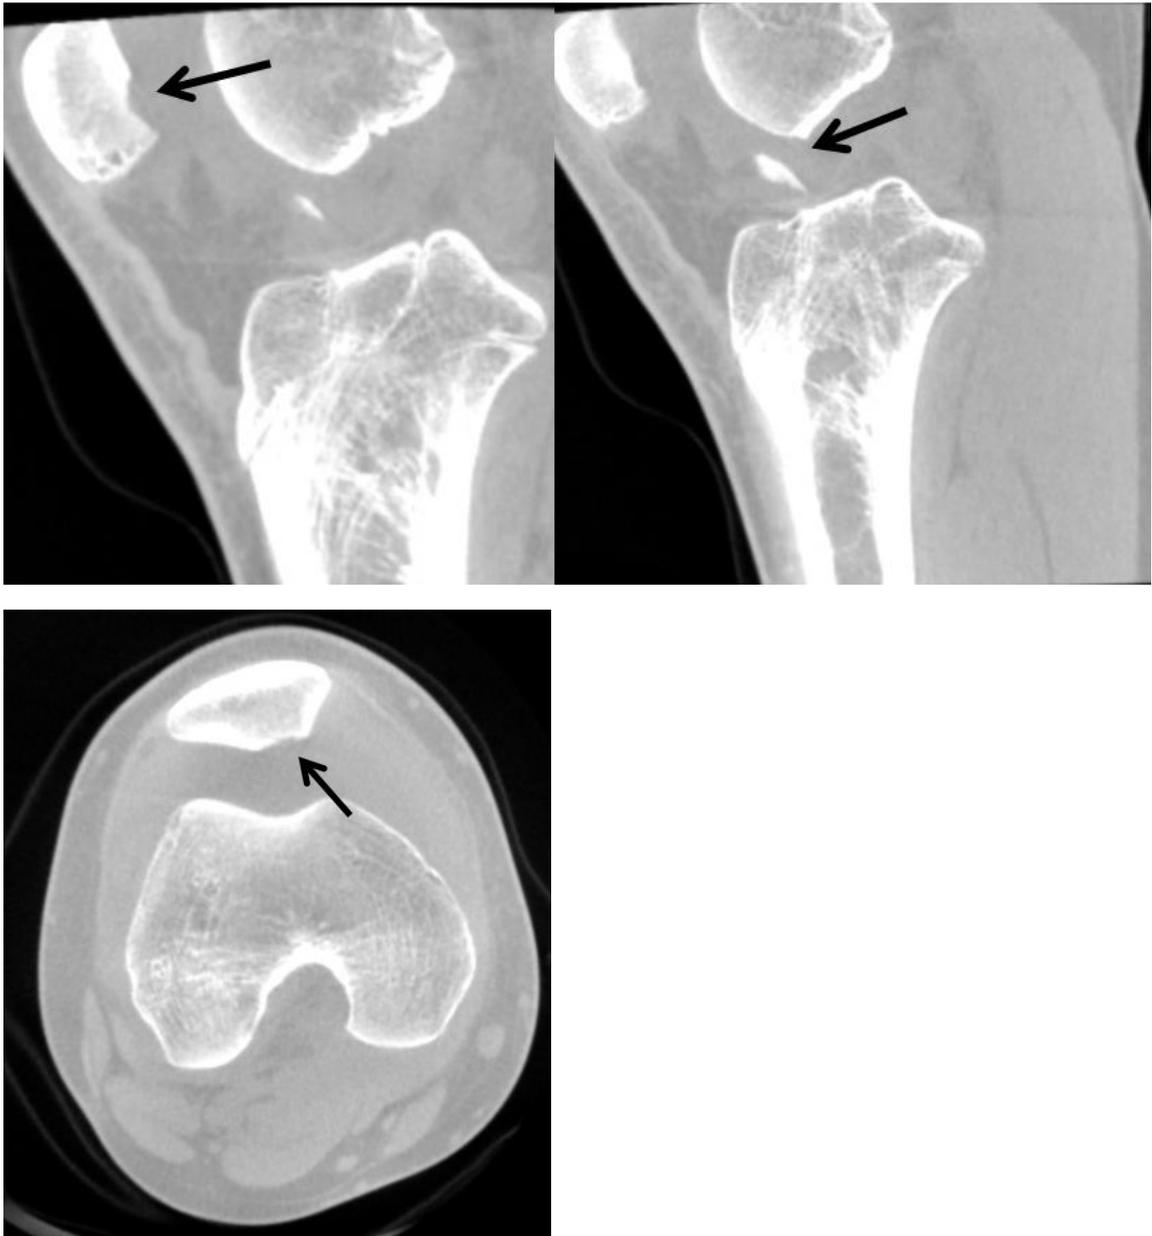
Figure 2 CT showed that the fragment was originating from a stress-bearing area, the distal apex of the patellae.

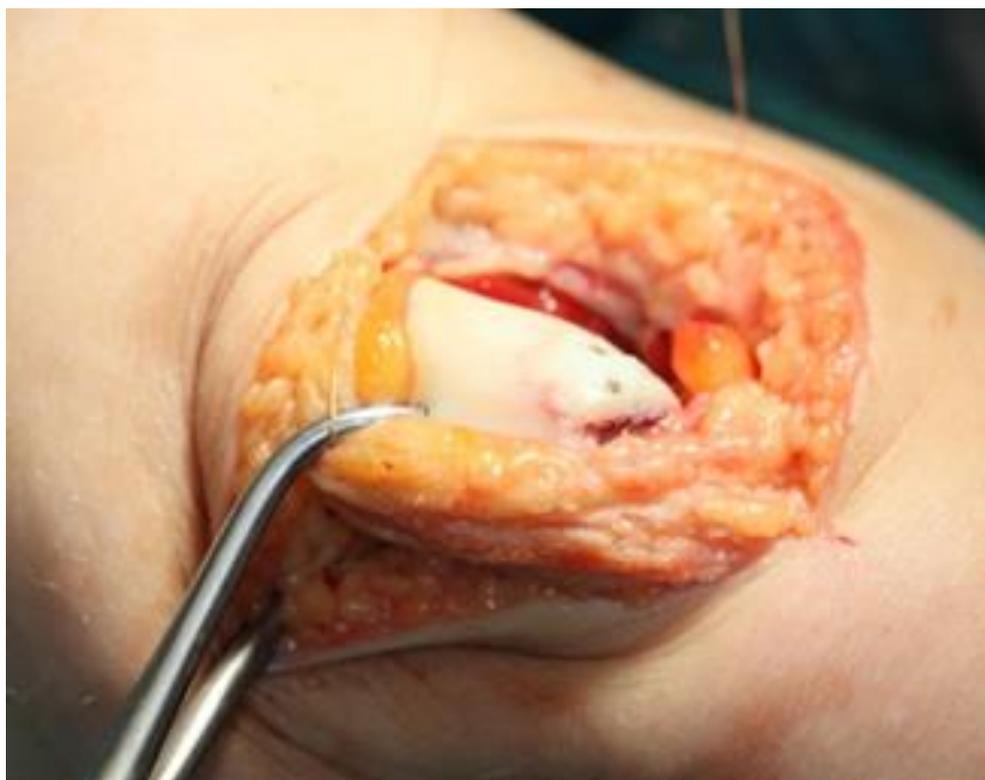
Figure 3 The loose part was adjusted into the defect and fixed using three ActivaPin™s

Arthrotomy was necessary due to the small dimensions of the child patient, instead of arthroscopy guided fixation. The knee was drained empty and a vertical parapatellar approach was performed. Soft tissues were dissected to approach the patella. The patella was then everted 90 degrees laterally using AO-forceps, in order to get direct access to the injury lesion. The surface of the defect area was rasped. The loose part was adjusted into the defect. It was discreetly compressed against the patellar bone, followed by a contemporary fixation by two 1.4 mm Kirshner wires and one 2.0 mm Kirschner wire. Thereafter, the wires were replaced by two **ActivaPin™ 1.5 mm** and one **ActivaPin™ 2.0 mm**. The pins were inserted using an ActivaPin™ Applicator. No notch or unevenness was remaining at the joint surface (Figure 3). The stability was good after fixing the fracture with three pins.

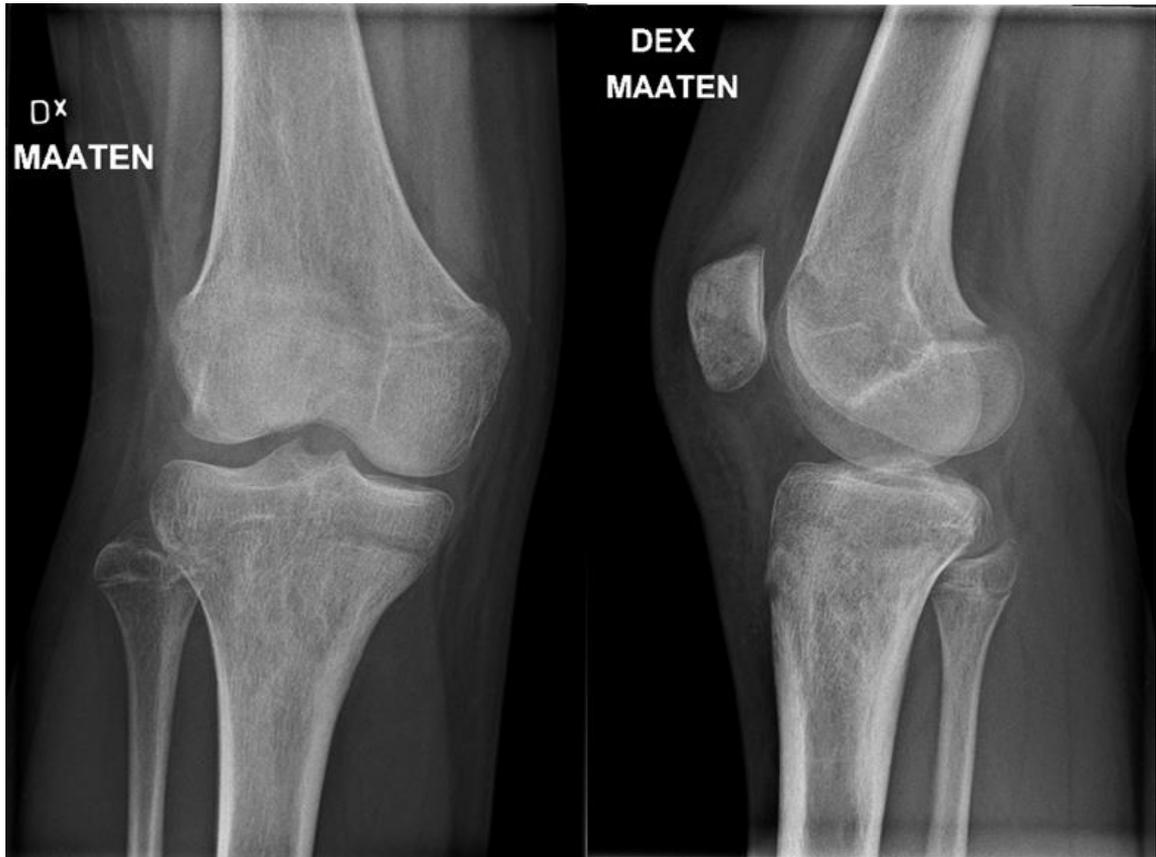
Figure 4 In radiographs six weeks after operation, the loose bone part was ossifying and the patellar joint surface looked smooth.

In the follow-up radiographs the loose bone part was ossifying. The patellar joint surface looked smooth (Figure 4). Physiologic osteopenia was seen overall in the knee radiographs, resulting from immobilization of the lower extremity in several weeks. A CT was performed to evaluate the final outcomes about two months after operation. Good bone healing was seen (Figure 5). The femoral-patellar joint seemed intact.

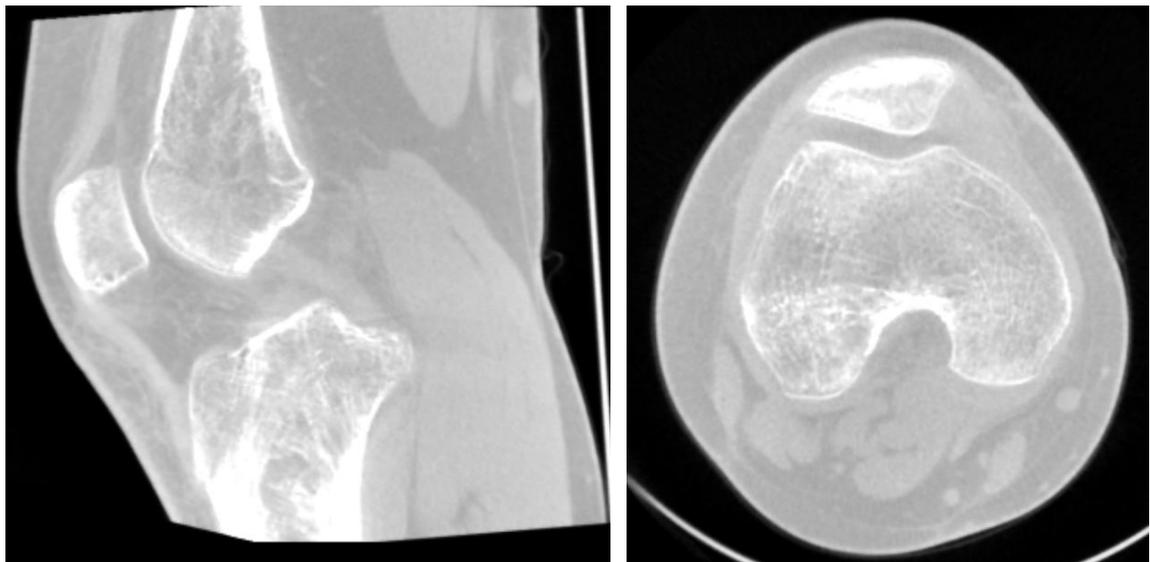
Figure 5 CT was performed to evaluate the final outcomes about two months after operation. Good bone healing was seen. The femoral-patellar joint seemed intact.

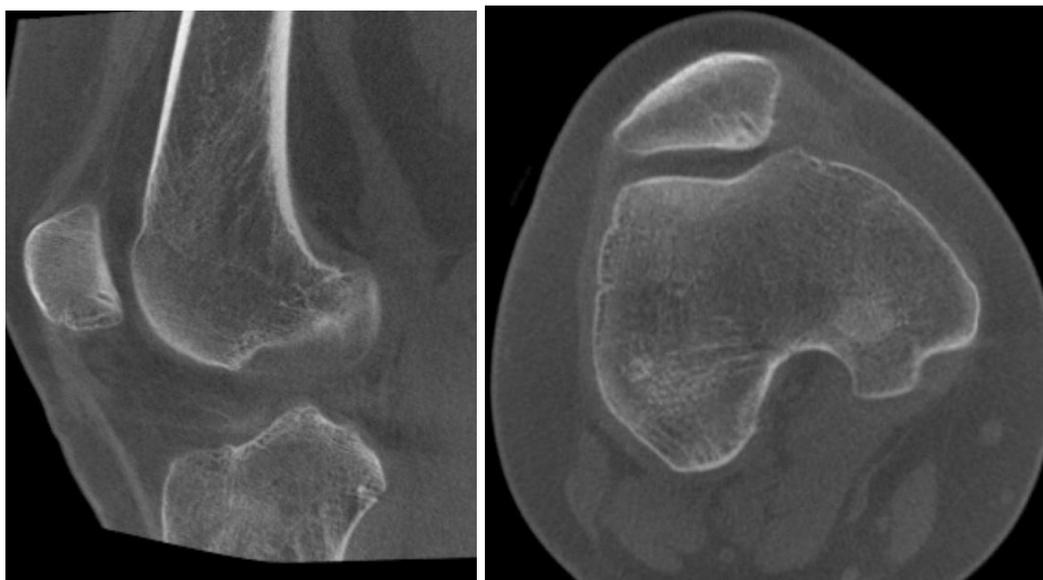
Figure 6 CT images, taken 13 months after operation, showed smooth and intact joint surface.

The long-term result was determined 13 months after the operation. The knee was symptomless. It was stable and the range of motion (ROM) was normal. The joint surface was smooth and intact in CT imaging (Figure 6). The follow-up was finished.
