Comminuted talar fracture reconstruction with multiple bioabsorbable ActivaNails™

Mr. Ziad Harb

CONSULTANT TRAUMA & ORTHOPAEDIC SURGEON

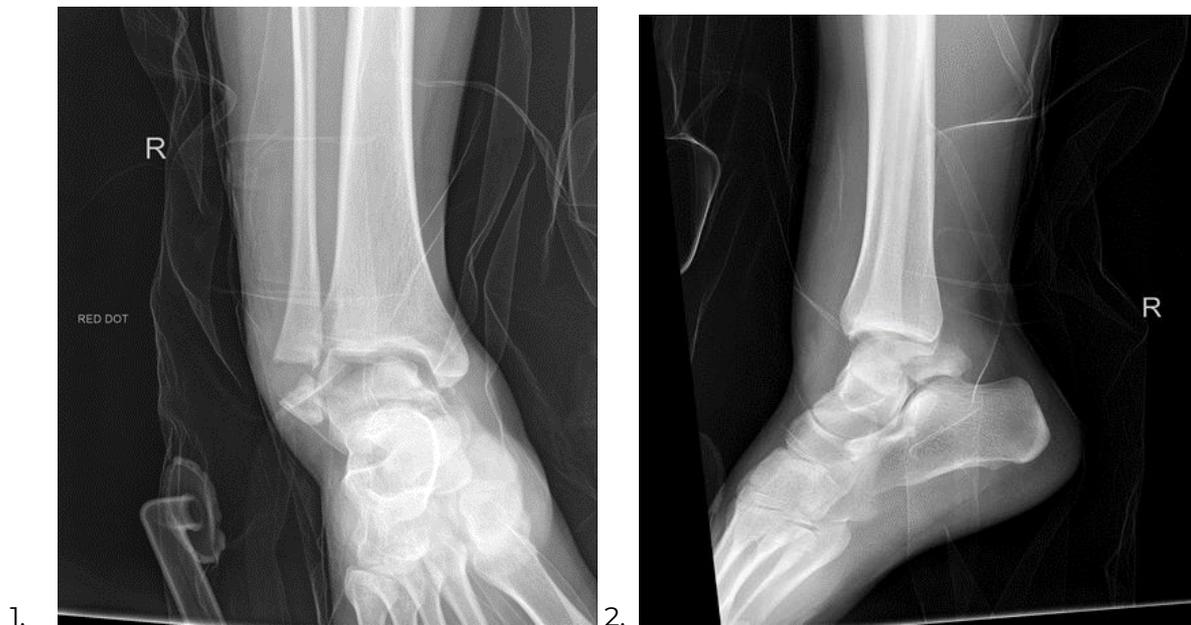
Images 1 and 2: Initial radiographs showing the comminuted talar body and distal fibula fractures.

A 17-year old, fit and healthy, female was admitted to her local hospital after falling from a horse. She sustained closed, comminuted right talar body and distal fibula fractures (images 1 and 2). After initial resuscitation and emergency management including closed manipulation of the fracture-dislocation, the leg was immobilised in a below-knee backslab, and the patient was admitted for observation. The patient was otherwise fit and healthy, had no drug allergies and did not smoke.

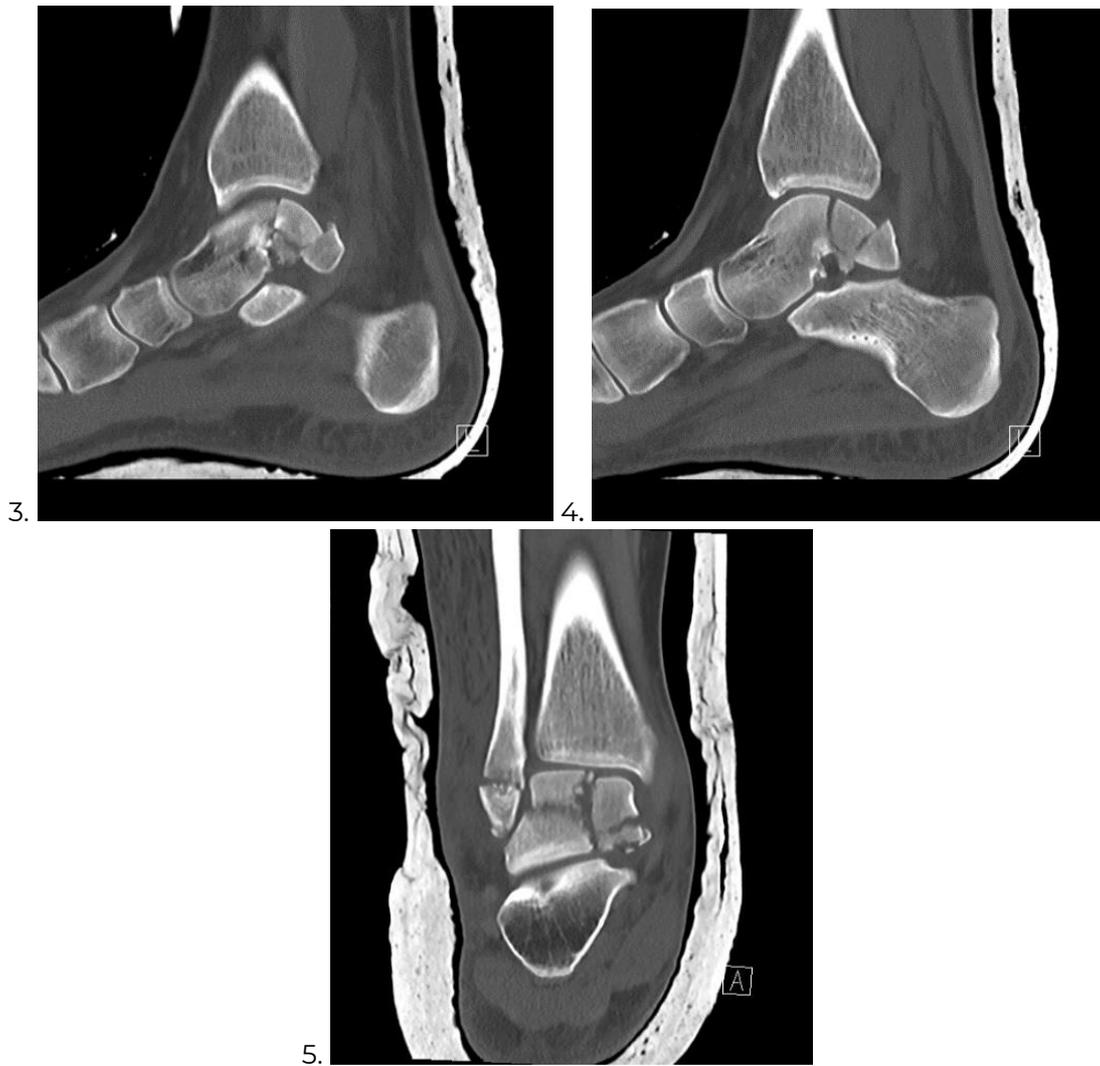
Images 3, 4 and 5: CT scan showing the detailed morphology of the fractures.

Once deemed stable, she was referred to our department, a regional tertiary complex trauma and limb reconstruction unit. Full imaging, including CT, was performed to understand fracture morphology better and allow for accurate pre-operative planning (images 3, 4, and 5).

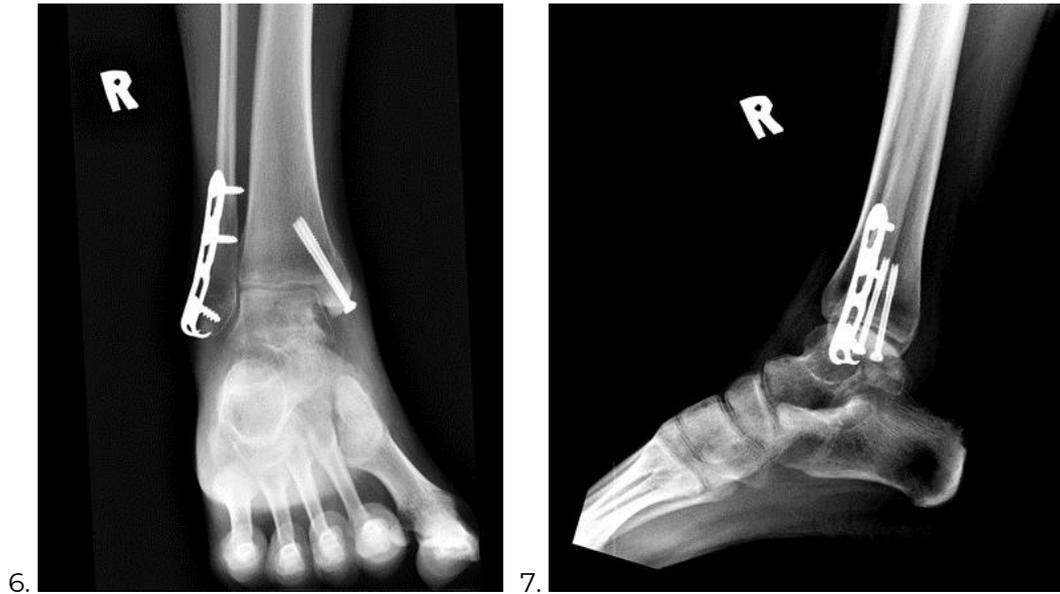
Images 6 and 7: Post-operative radiographs showing the reconstruction of the talus with Bioretec bioabsorbable ActivaNail™s, and the fixation of the medial and lateral malleoli with standard hardware.

The reduction was held using temporary K-wire fixation, then a combination of Biorettec's 1.5 mm and 2 mm ActivaNails™ were inserted. Once the talus was reconstructed with ActivaNails™, the fibula fracture was reduced and fixed using a 3.5mm locking hook plate. The medial malleolar osteotomy was fixed with cannulated 3.5mm screws (images 6 and 7). Soft tissue repairs of the partially torn AITFL and tibialis posterior tendon sheath was performed. The wounds were closed with bioabsorbable sutures, and the leg placed in a below-knee backslab.

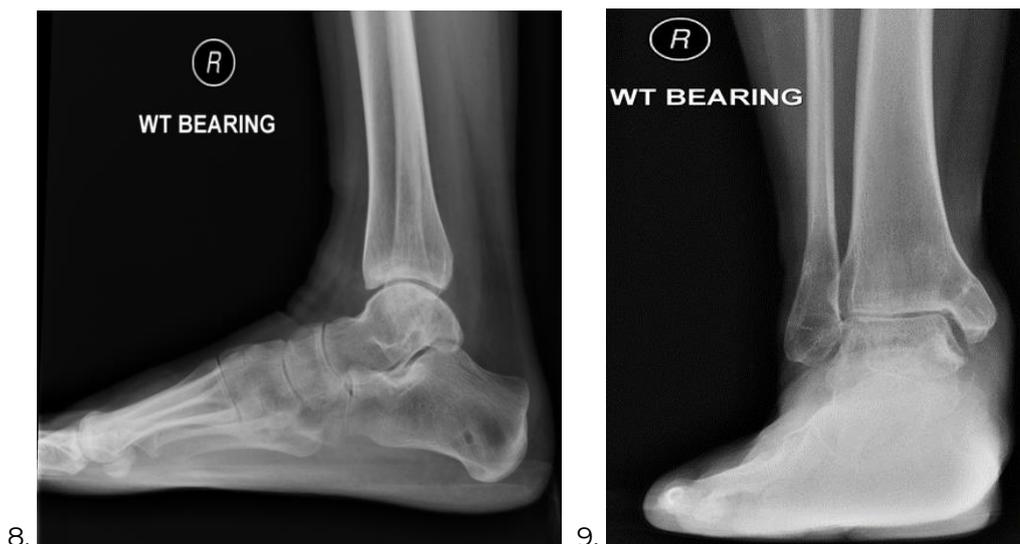
Images 8 and 9: Post-operative radiographs after removing the metal hardware of the medial and lateral malleoli. Note the intact congruity of the talar head and maintained joint space at just over one-year follow-up.

The patient was mobile but non-weight bearing on the right leg for six weeks, followed by a further four weeks partially weight-bearing in an immobiliser boot whilst maintaining early range of motion exercises. She commenced further physiotherapy and regained full movement of her ankle. Serial radiographs demonstrated a satisfactory position and progression towards union. After seven months, the prominent distal fibula metalwork and medial malleolar screws were removed (images 8 and 9).

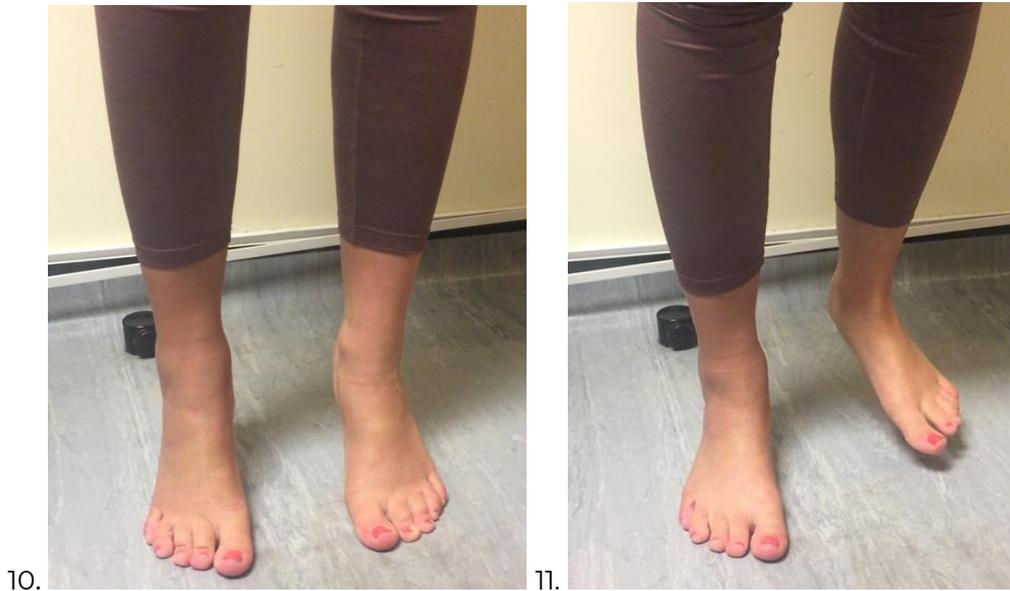
Images 10 and 11: Bilateral and single stance heel raise, demonstrating the excellent clinical function at one-year post-op.

At one year, the patient had returned to full activities, including horse-riding, and demonstrated an excellent pain-free ankle and subtalar range of motion (images 10-13), and satisfactory radiological appearance with intact articular surfaces and well-maintained morphology of the talus.

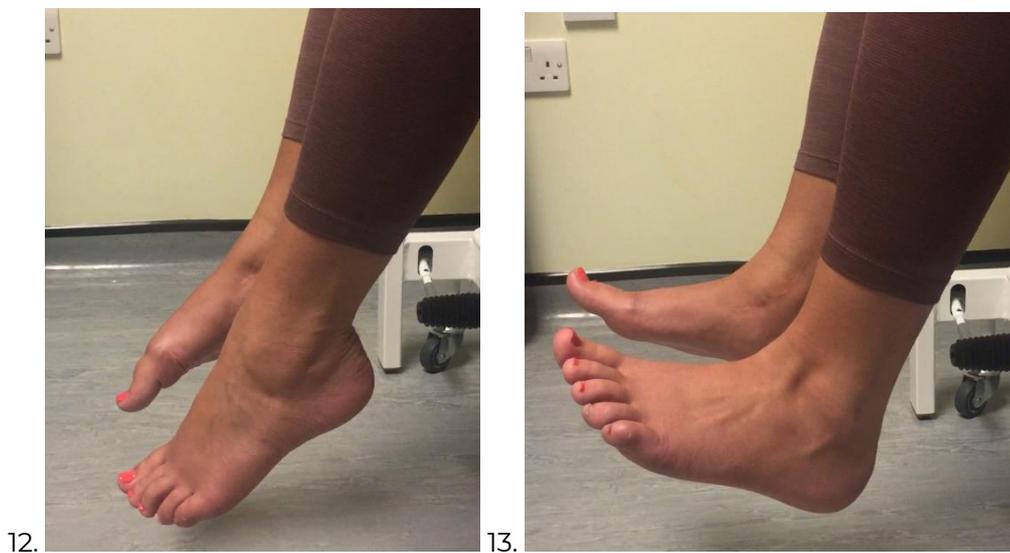
Images 12 and 13: clinical photographs are demonstrating the excellent ankle range of motion.
